## WILLISTON BASIN DRAINAGE STUDY

**Williston Street at Evergreen Street  
Wheaton, DuPage County, Illinois**

City of Wheaton  
303 W. Wesley Street  
Wheaton, Illinois 60187

V3 Companies  
7325 Janes Avenue  
Woodridge, Illinois 60517  
630.724.9200

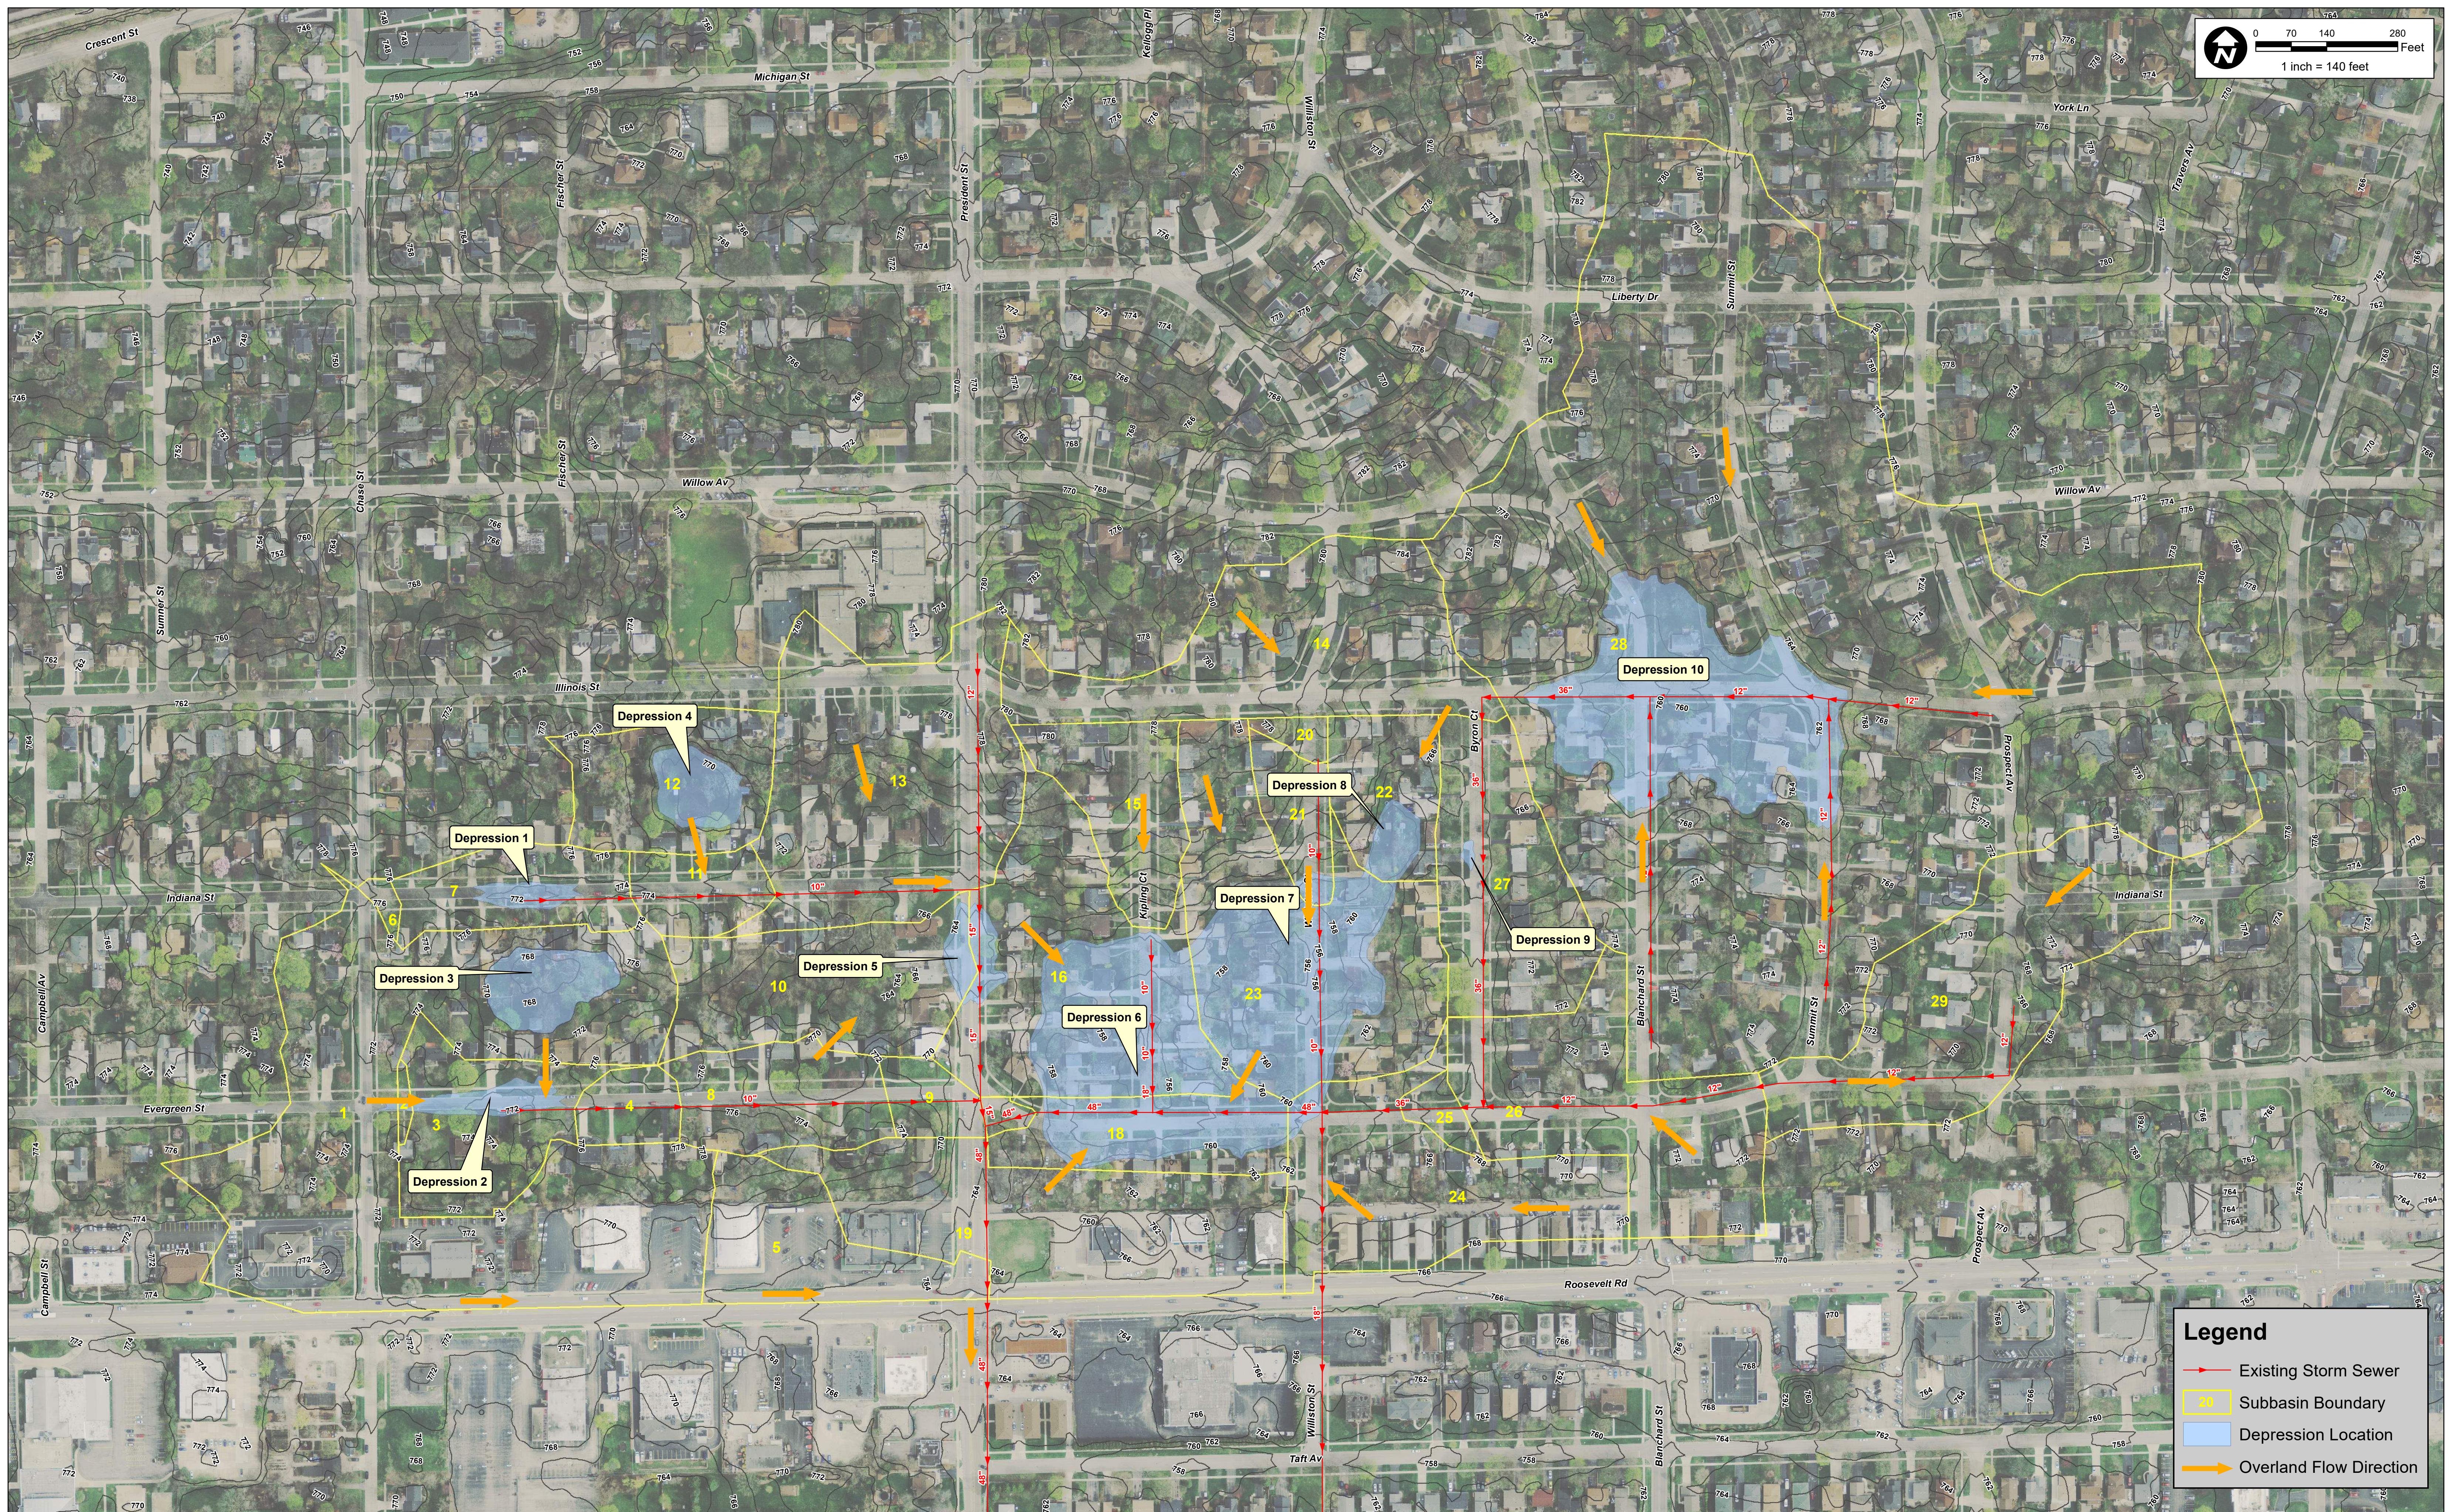
TITLE  
Existing Conditions Hydrologic Map

The V3 2012 existing conditions XP-SWMM hydrologic and hydraulic model of the Williston Basin was enhanced to determine peak critical duration Water Surface Elevations (WSEL) for the 500-year return interval storm event. A summary of tasks performed is provided below. Existing conditions hydrology is shown on Exhibit 4 and the XP-SWMM model is provided electronically in Appendix 6.

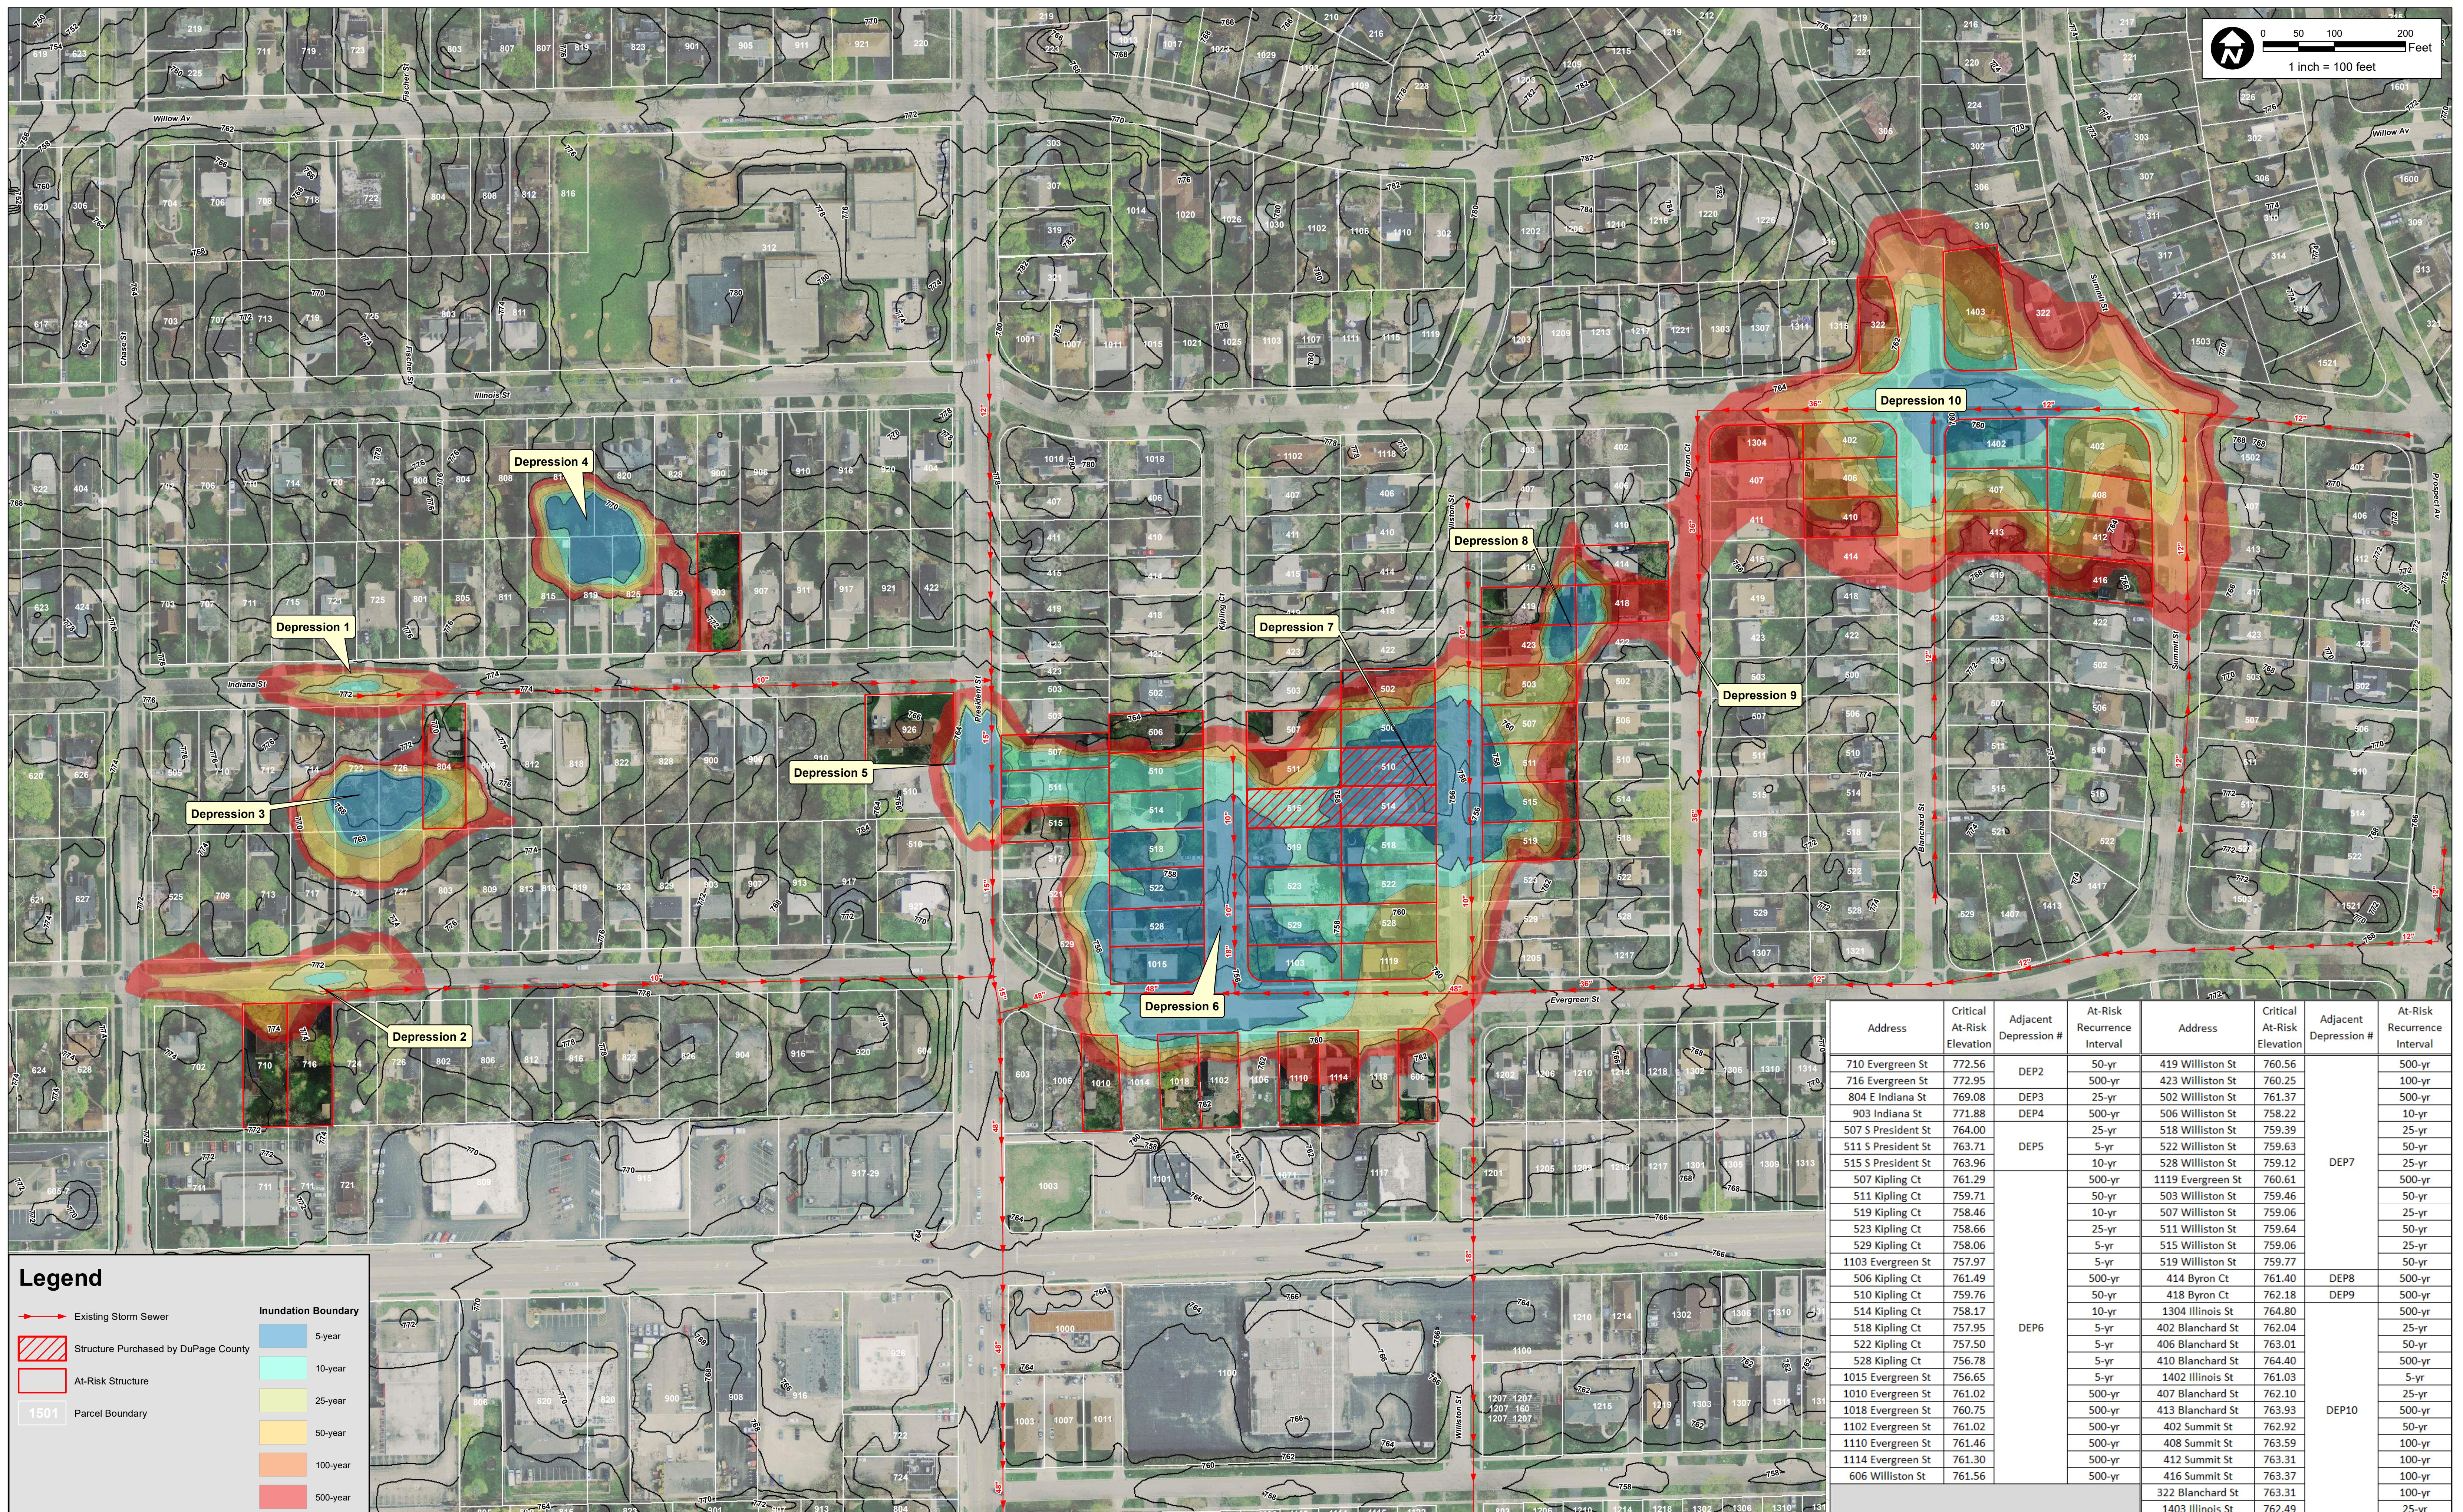
V3 obtained supplemental low entry survey of 100 structures located within the delineated 500-year inundation boundary and determined that 54 of the 100 structures have low entry elevations below the calculated peak 500-year WSEL. Existing conditions at-risk structures are shown on Exhibit 6.

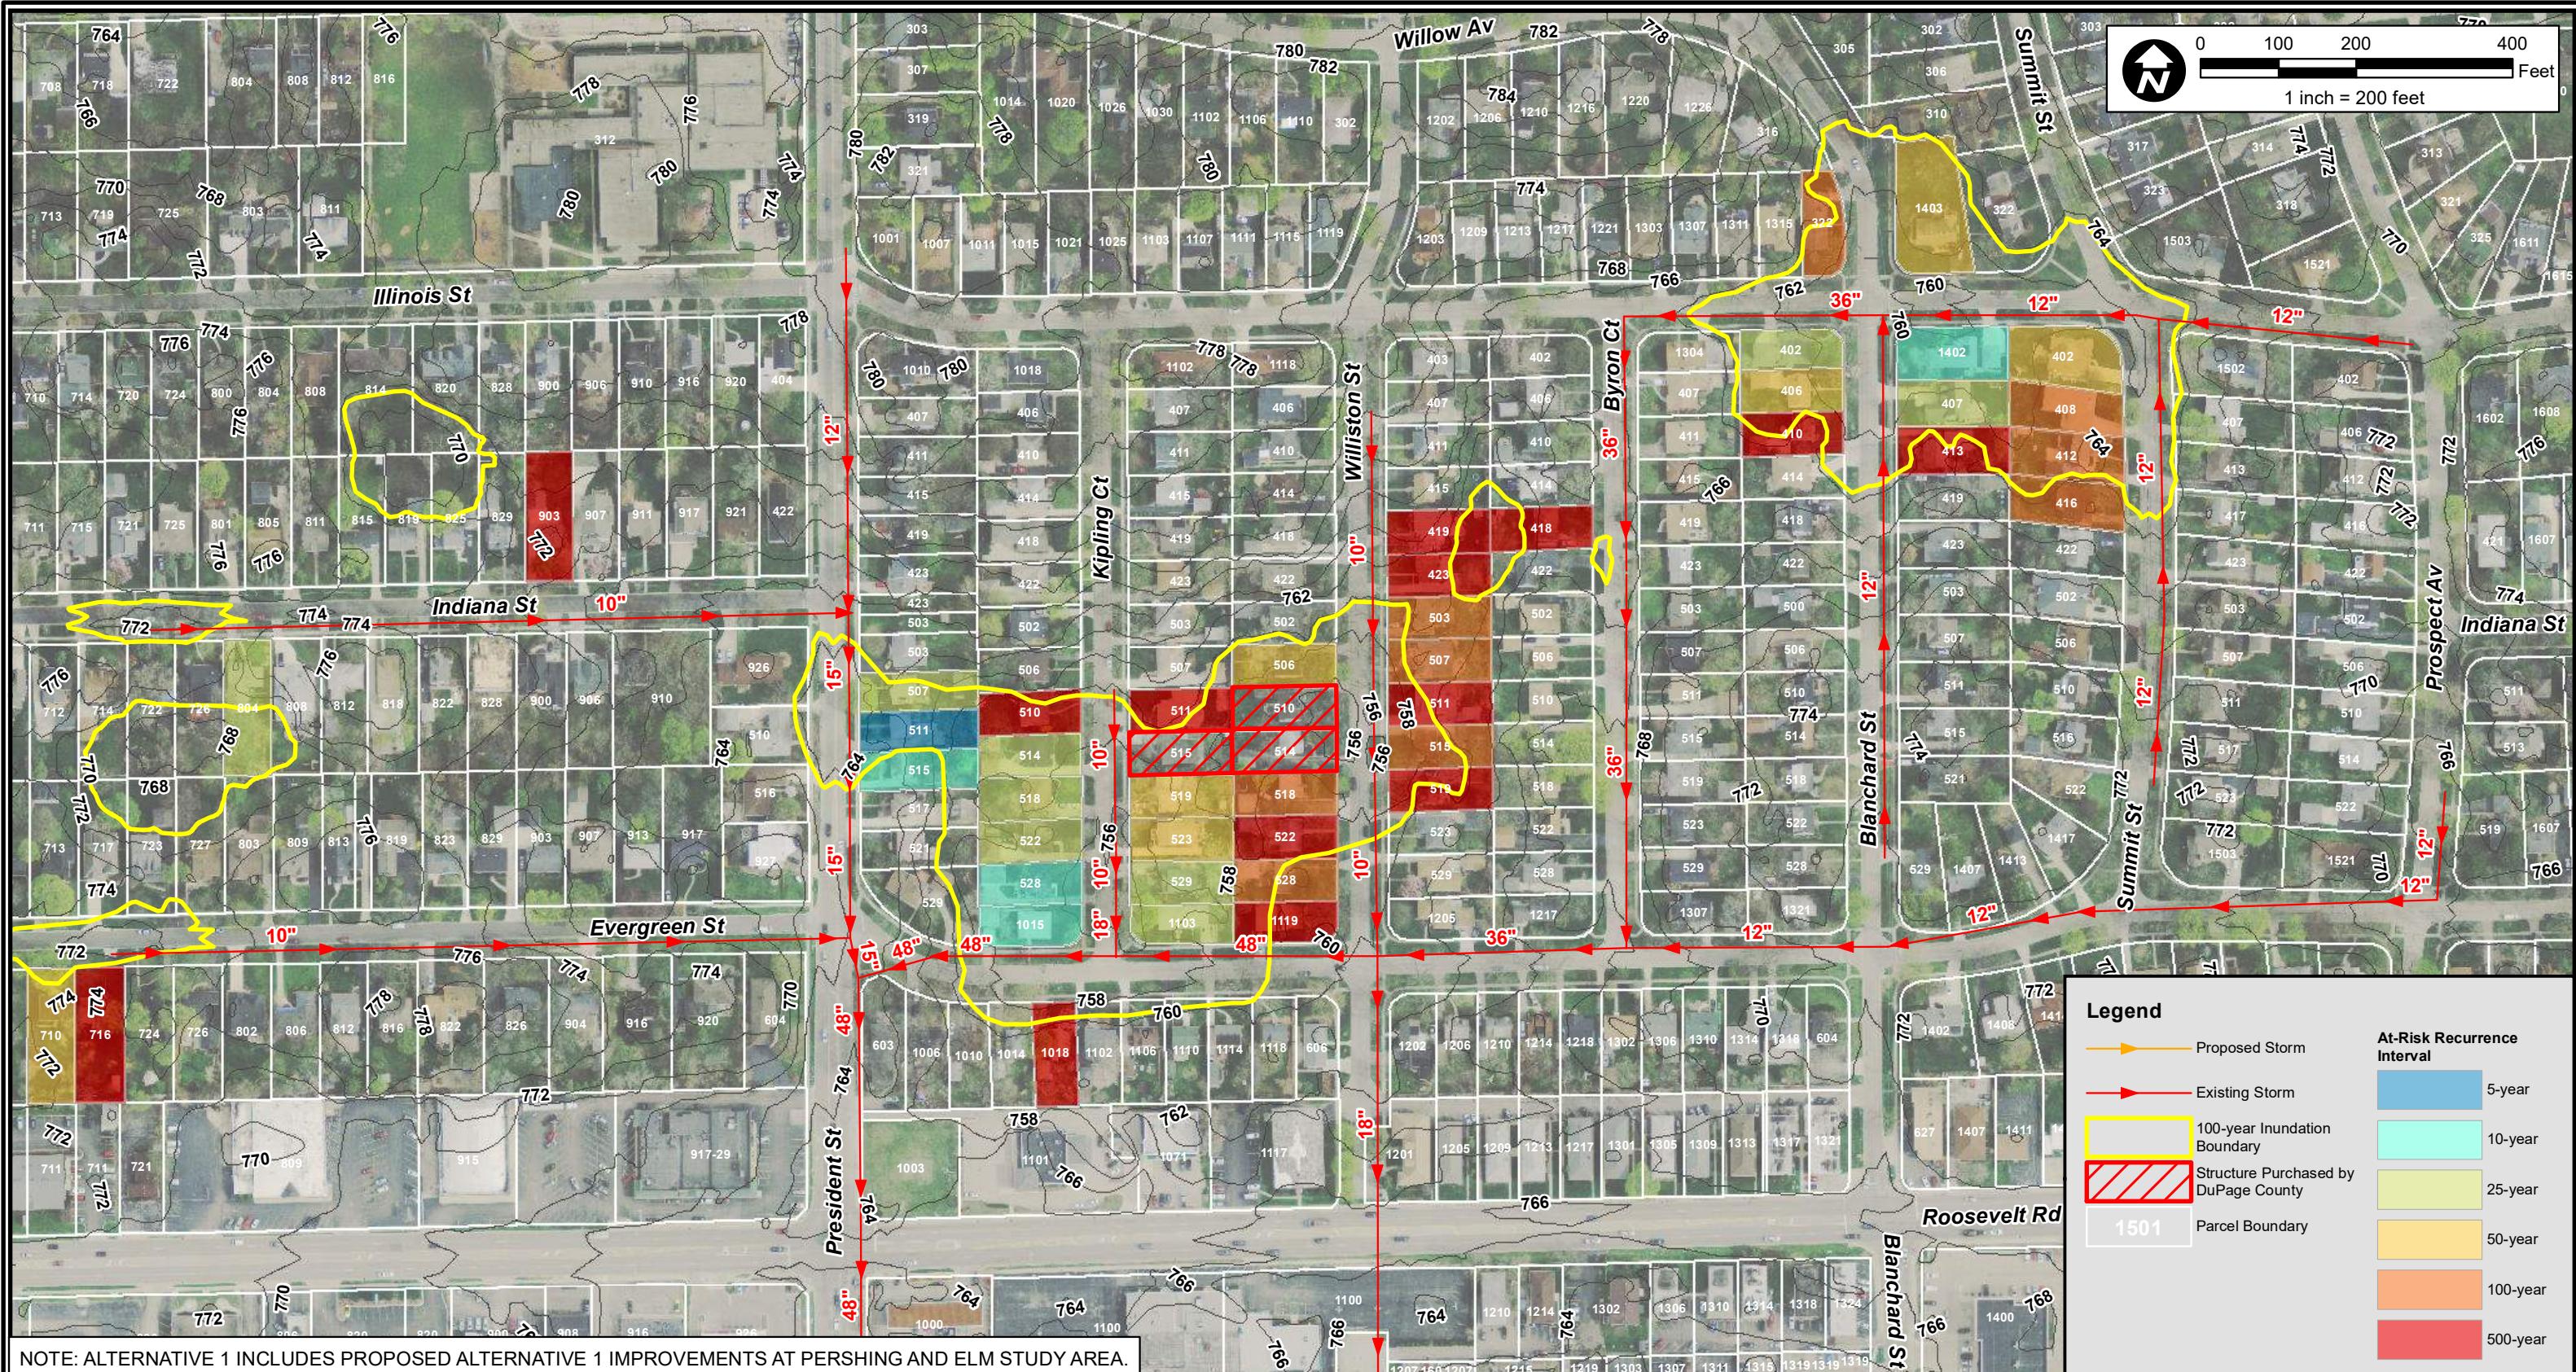
CLIENT	PROJECT#	DESIGN		CHECK
TITLE	12045.01	ISSUE DATE		EXHIBIT NO.
		09/13/18		
V3 Companies 7325 Janes Avenue Woodridge, IL 60517 (630) 724-9200 phone / (630) 724-9202 fax www.v3co.com	City of Wheaton Proposed Alternative 1			7B

XP-SWMM results show less than a 5-year level of protection at Depression 5, a 5-year level of protection at Depressions 6 and 10, and a 25-year level of protection at Depression 7. The peak 100-year WSEL at Depressions 6 and 7 is lowered by approximately 1-foot from existing conditions. In this alternative, 6 additional homes are

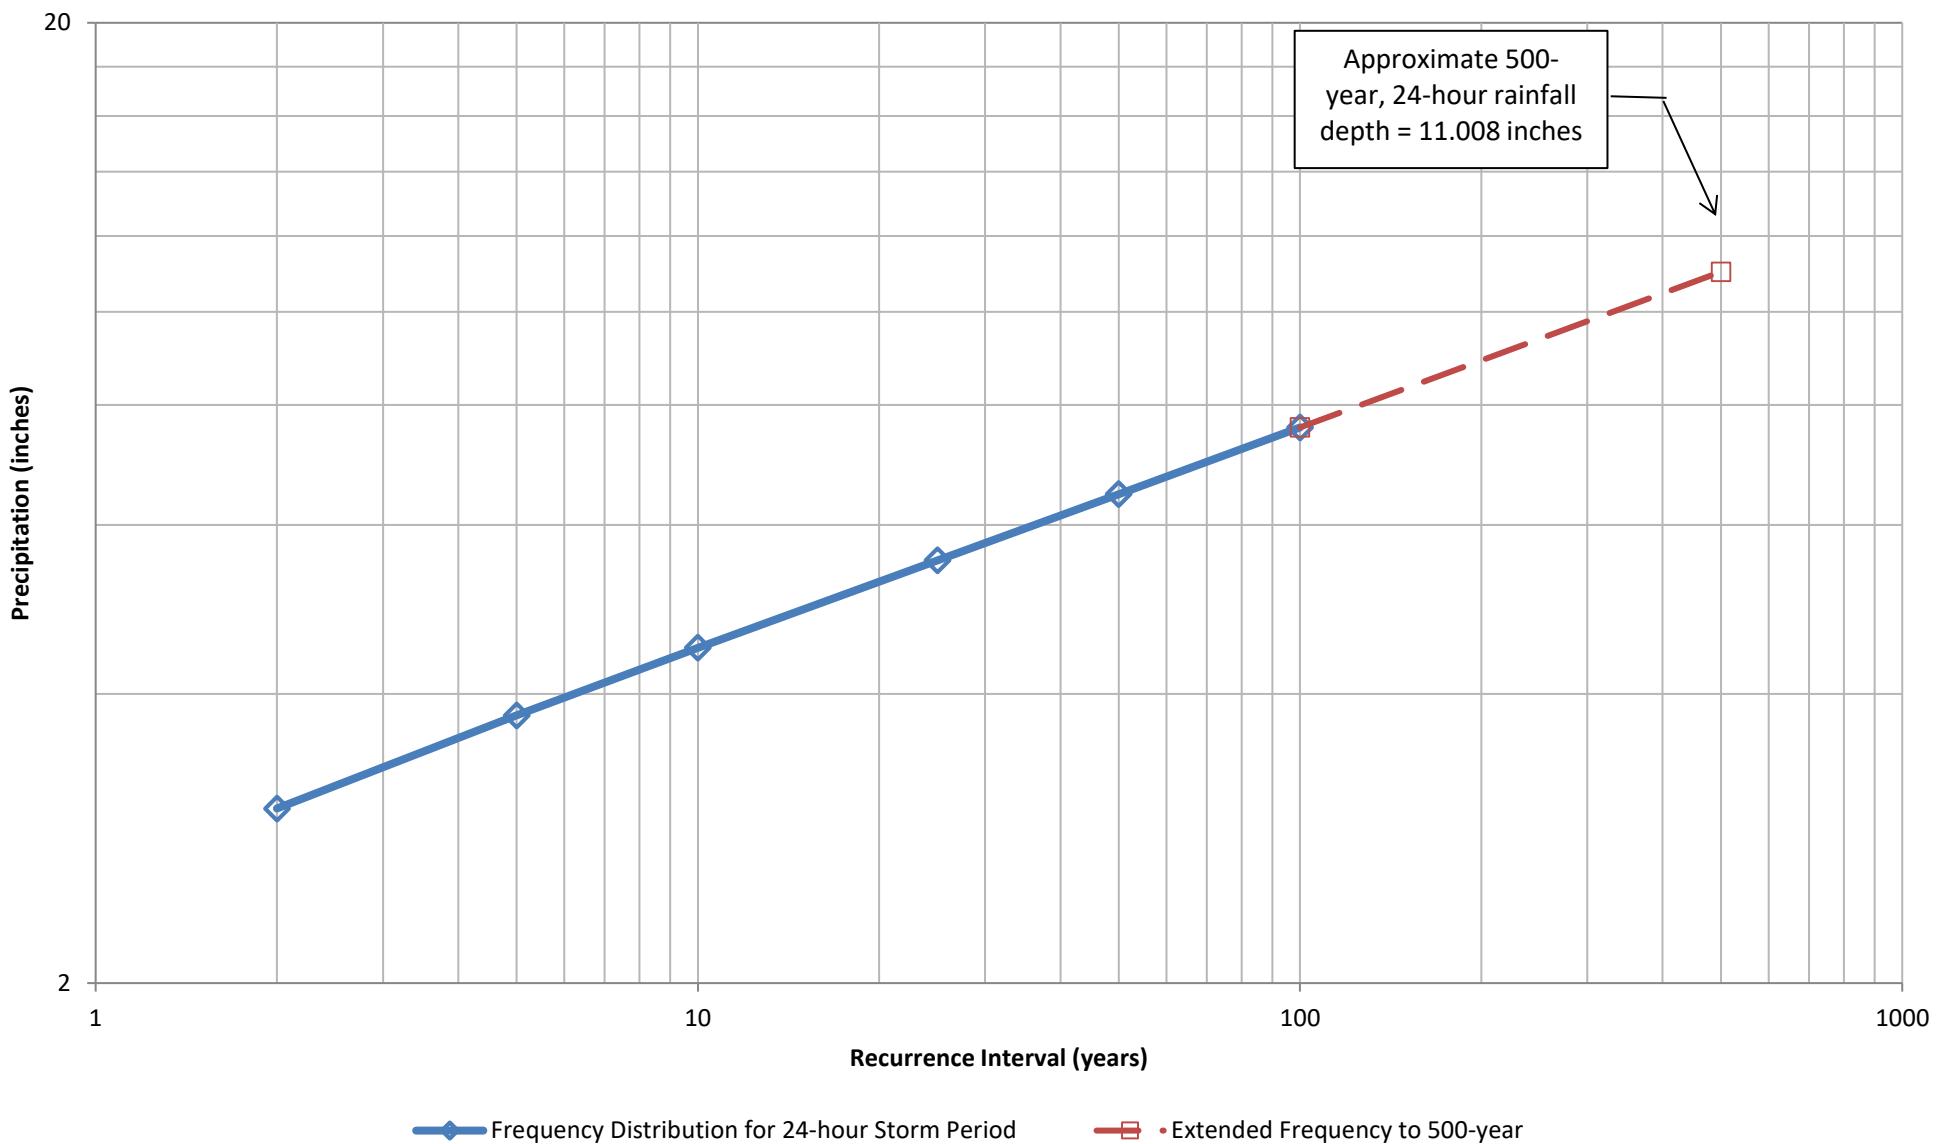
## Extrapolation Graph for 500-year Frequency - Bulletin 71 NE IL Sectional Depths

The 500-year rainfall depths were entered into the existing conditions XP-SWMM model and the critical duration WSEL for each depression was calculated. The 500-year WSEL inundation boundary was delineated on DuPage County 2-foot contour aerial topography as shown on Exhibit 5.

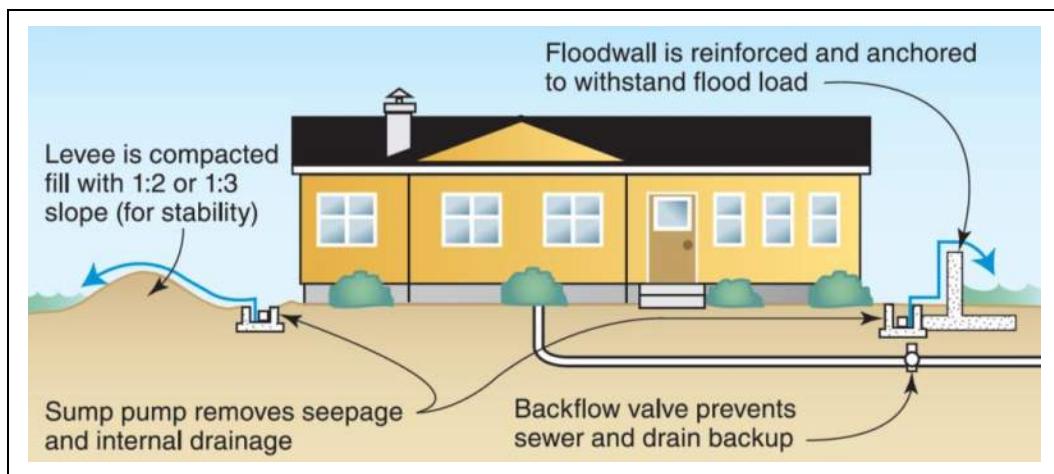
**Figure 1. Berm and Levee Examples (Source: FEMA P-312)**

When properly designed and constructed, berms and levees can be effective in reducing structural damage from overbank flooding. The sides of a levee or berm are sloped to provide stability and resist erosion, thus the width is usually six to eight times its height. As a result, taller levees require more land. A floodwall is an engineered structure made of reinforced concrete or reinforced concrete block and varies in height from 1 foot to 20 feet. Similar to berms and levees, a floodwall can surround a structure or a portion of a structure. A typical levee and floodwall used to protect a residential structure are shown in Figure 1.

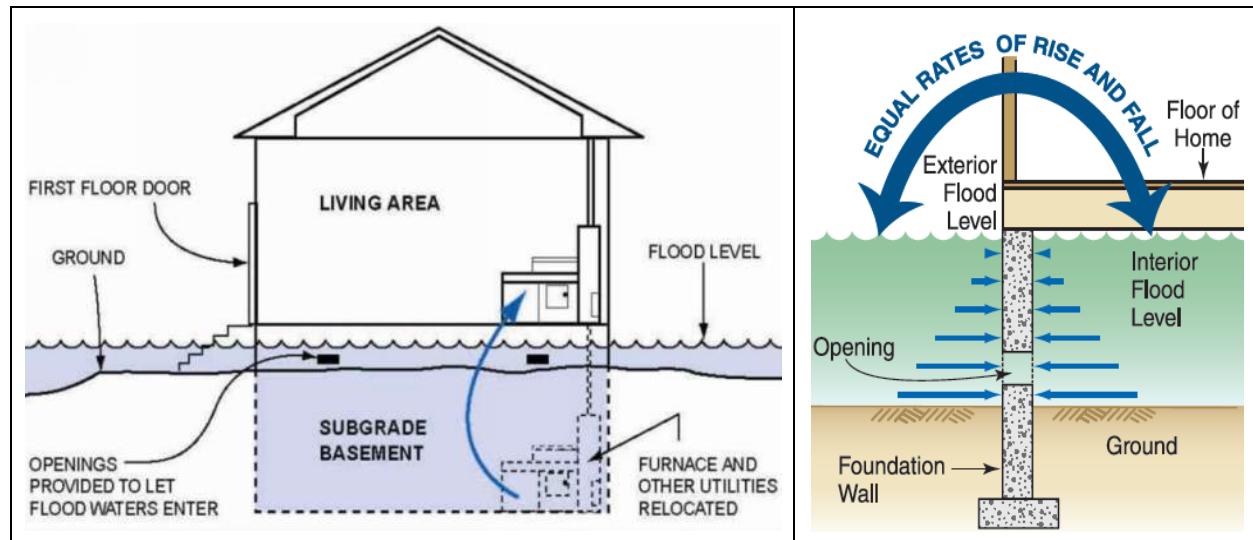
A typical example of a residential structure with openings is provided in Figure 2 along with a graphic showing the equalization of pressure on both sides of the opening.

**Figure 2. Wet Floodproofing Example (FEMA P-312, June 2014).**

Installing openings allows water into the structure, eliminating differential pressure on either side of an enclosed space and preventing collapse of those walls as a result. There is not a reduction in flooded properties by installing openings, but there could be a reduction in flood damages.

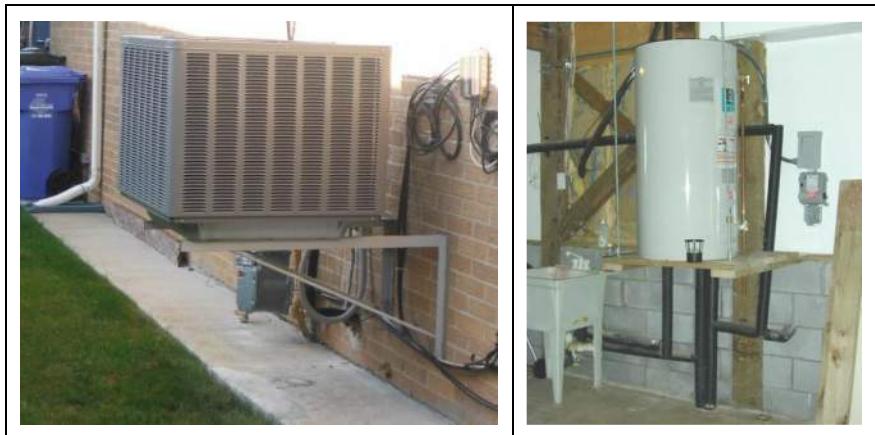
Raising utilities above the anticipated water level protects them from being submerged during a storm event, thus minimizing replacement costs. When essential equipment is located below grade, elevating typically requires relocating the equipment to higher floors in the building. Unless space is already available, moving the equipment to a higher floor may reduce the available living space. Building owners may need to evaluate all available space, including the attic and second floor, to determine whether a small elevated addition would be an acceptable solution. Some examples of elevated utilities are shown in Figure 3.

***Figure 3. Elevated Utilities Examples.***

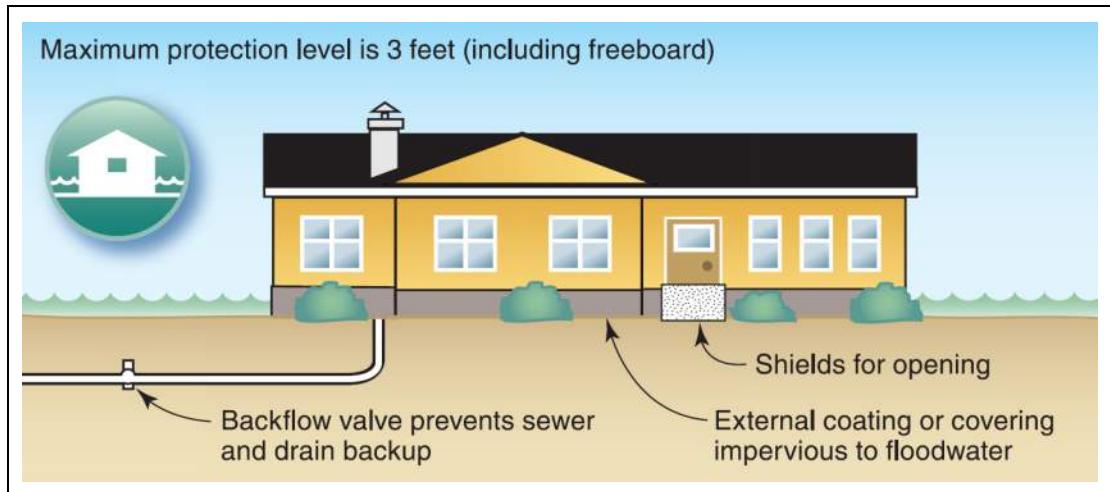
Dry floodproofing completely seals the exterior of a building, below the anticipated water level, to prevent the entry of floodwaters keeping the interior of the structure dry. An example of dry floodproofing is provided in Figure 4.

**Figure 4. Dry Floodproofing Example (FEMA P-312, June 2014).**

Unlike wet floodproofing, which allows water to enter the building through wall openings, dry floodproofing seals all openings below the flood level and relies on the walls of the building to keep water out. Even if a structure is dry floodproofed, water can still seep through small openings in the sealant system or through the gaskets of shields that are protecting openings. Internal drainage systems are required to remove any water that has seeped through and remove water collected from any necessary underdrain systems in the below-grade walls and floor of the home.

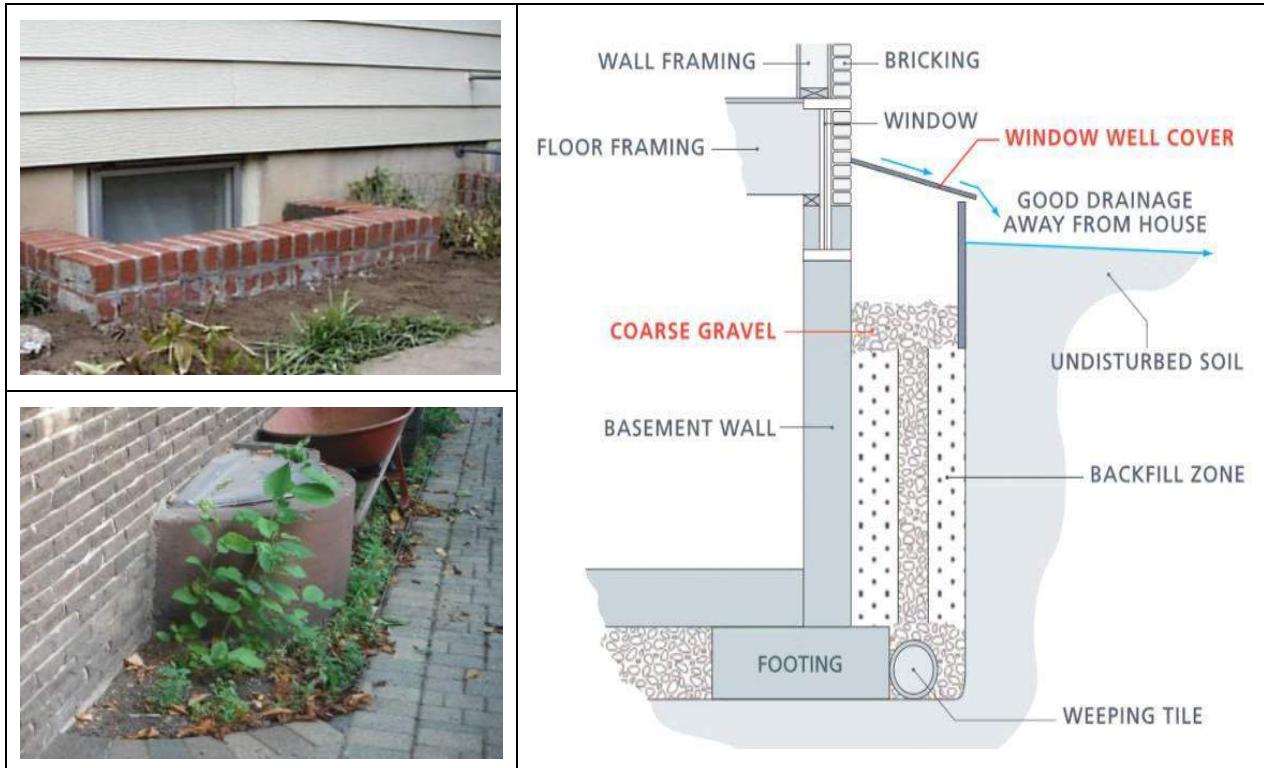
Properties that do not have adequate protection of their low opening (window or basement door) can effectively raise the low opening height with a window well. Window wells can help improve drainage around basement windows to prevent water from entering the basement and can reduce dampness inside the structure. Window wells can also help to prevent rotting of window sills, which may compromise the ability of the windows to hold back flood water. Examples of raised concrete window wells are provided in Figure 5.

**Figure 5. Raised Window Wells. (Source: FEMA 551)**

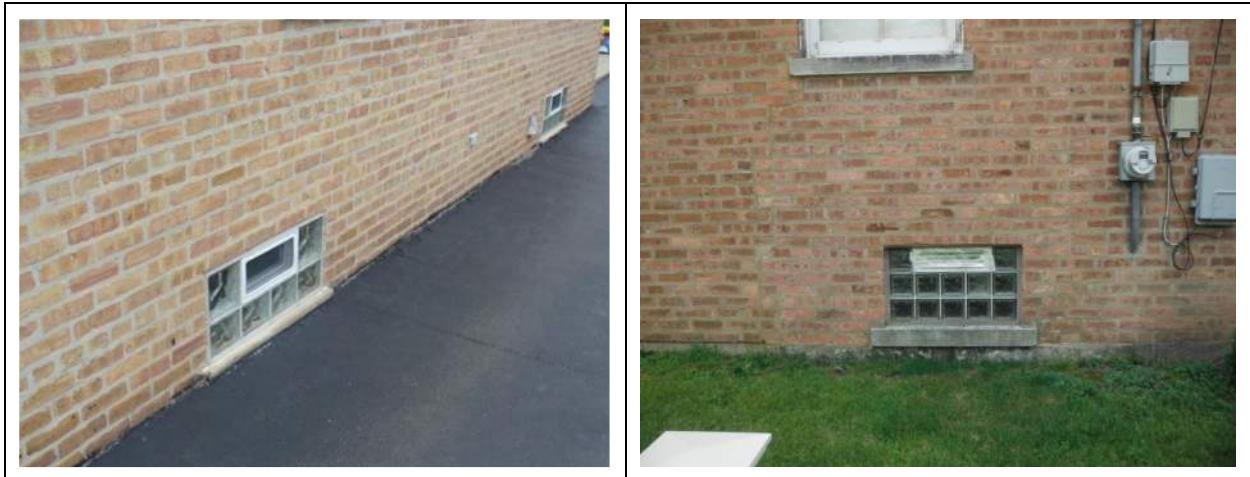
An alternative to a raised window well is to remove the glass from the window and replaced it with glass blocks. When installed properly, glass blocks can withstand the pressure of a small amount of ponding floodwaters. The glass blocks will reduce the occurrence of seepage through a lower level window; however, they can only be used in limited applications. Some examples of low level windows that were successfully replaced with glass blocks are shown in Figure 6.

***Figure 6. Glass Block Window Examples.***

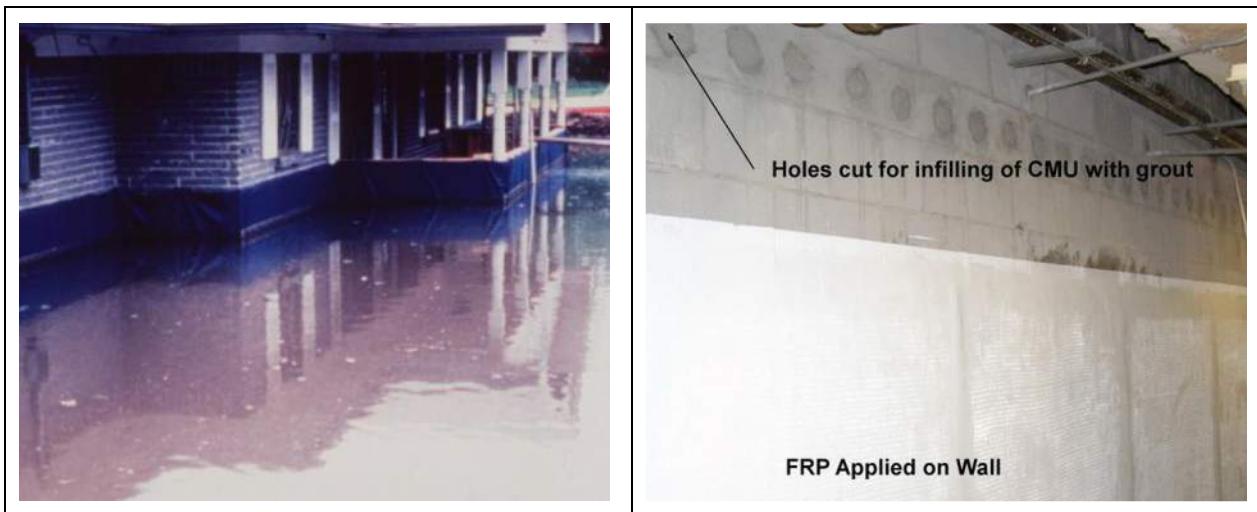
Creating a waterproof barrier in a section of wall to make it impermeable may require the use of sealants. Sealants are applied directly to the exterior surface of the building to seal exterior walls and floors. Sealants can be either positive-side (applied to the wall exterior where the sealant acts as a barrier between floodwaters and the wall) or negative-side (applied to the interior of a wall or floor where the water pushes against the sealant after it has passed through the wall or slab) as shown in Figure 7.

**Figure 7. Positive-side Sealant (left) and Negative-side Sealant (right) Examples**

Above-ground walls can be sealed using either category of sealant because interior and exterior sides are both typically accessible, while below-ground walls and floor slabs almost always require negative-side sealants. The appropriate sealant for a particular structure is dependent upon the compatibility of the sealant product with the expected duration and depth of flooding and the construction materials in the building.

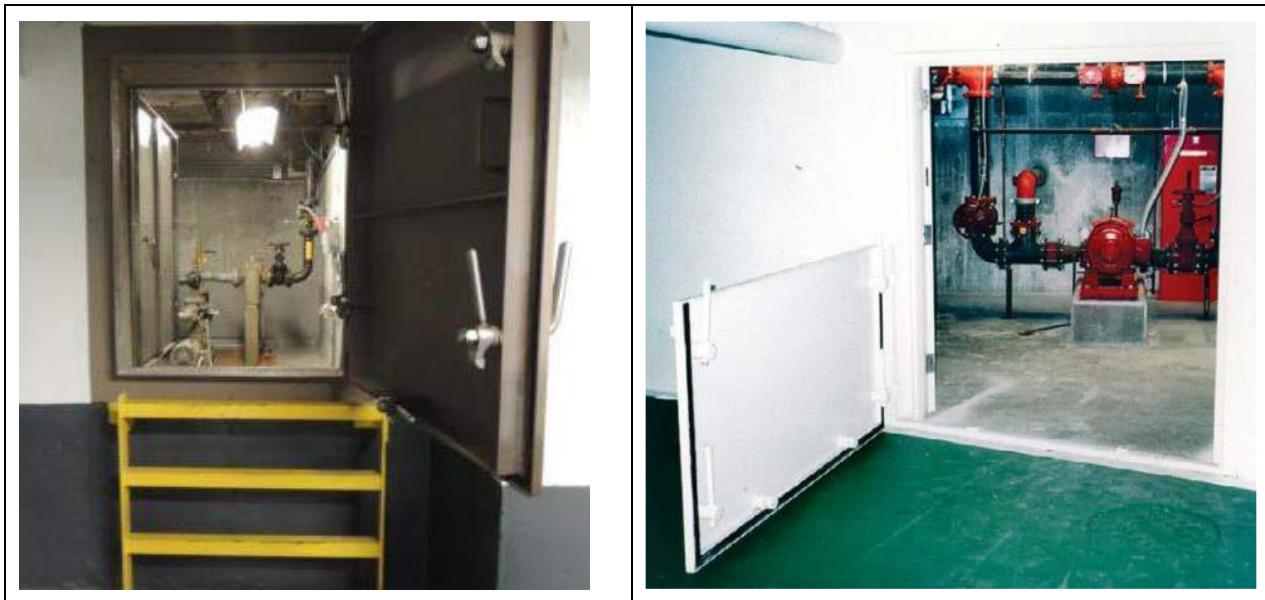
Critical core components and areas can be made flood resistant even if dry floodproofing the entire building footprint is not needed or possible. Typical critical core areas contain utilities such as electrical services, emergency generators, emergency fuel supplies, and other components that cannot be moved or elevated. In many large complexes or campuses of buildings (such as museums, universities, and large businesses), the utilities may be housed in a central building and linked to the other buildings via tunnels. Although the main utility building may not be at risk of flooding during a particular event, utility tunnels are often subject to more frequent flooding. Examples of watertight doors that would prevent flooding of a utility room are provided in Figure 8.

**Figure 8. Floodproofed Core Area Examples**

An important consideration in making a core area watertight is that floodwater levels may be higher than the height of typical dry floodproofing measures that protect the entire building, and additional anchorage may be needed to make sure the area does not become buoyant. Both the floor system and existing walls should be carefully studied and evaluated. Because these areas are typically designed to be fully resistant to high flood loads, additional anchoring or securing of the core area may be required to resist buoyancy forces.

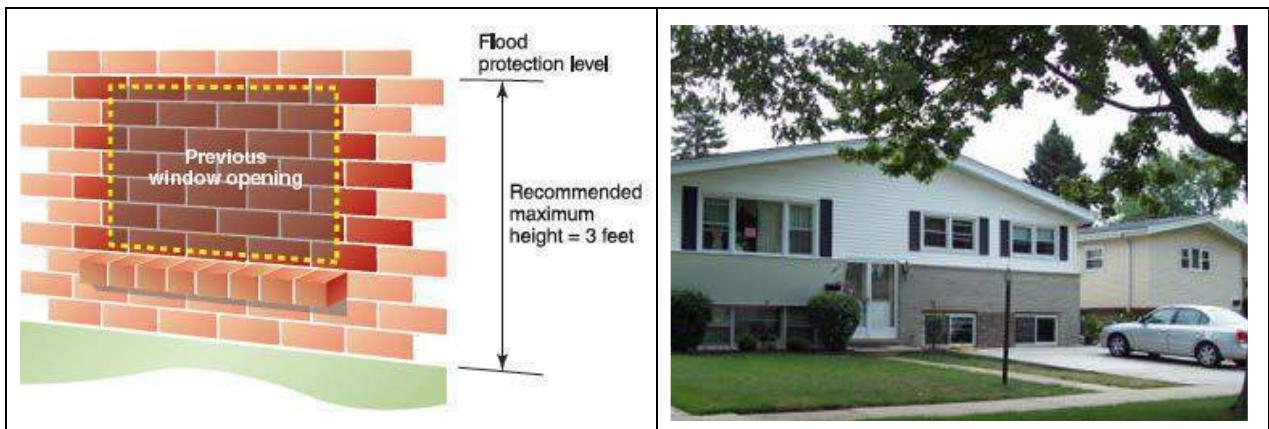
Penetrations through walls for utilities have much narrower openings than those of doors or windows. Gaps in the opening around the utility line should be filled with expansive foam to create a waterproof seal. Sealants used to seal openings in walls or floors should be able to withstand being submerged for the anticipated duration of flooding. Two examples of sealed openings are provided in Figure 9.

**Figure 9. Sealed Window Opening (left) and Sealed Garage Opening (right) Examples**

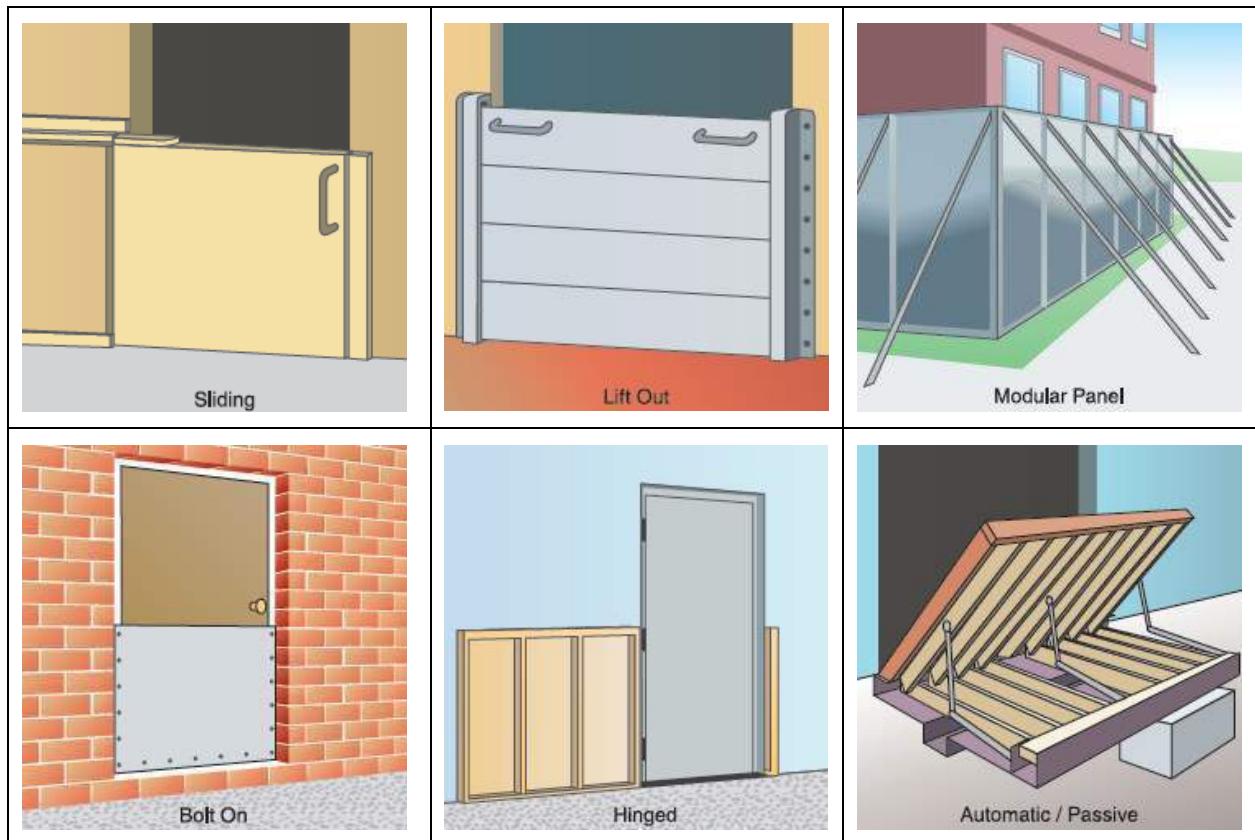
During flood conditions, doors typically present the largest openings requiring protection from water intrusion into the building. Flood shields or panels are watertight structural systems that bridge the openings in walls to prevent the entry of floodwaters. Flood shields work in tandem with waterproof barriers to resist water penetration. Although flood shields are most often temporary measures, they can also be used as a permanent floodproofing measure. Flood shields transfer flood-induced forces to the adjacent structural components, which can overstress the structural capabilities of the building. Most flood shields are mounted against the exterior of the opening, allowing rising floodwaters to further compress the gaskets and seals between the flood shield and the wall system or frame of the opening. Some examples of removable flood shields for exterior openings are provided in Figure 10.

**Figure 10. Example Flood Shields for Exterior Openings.**

The type of shield that is used depends on the size of the opening that needs to be protected, the duration of flooding, the normal use of the opening, warning time available to install the shield and the use of the door as a means of egress from the building. For larger openings, passive (automatic) flood shields may be preferred to active flood shields, which require human intervention. Passive flood shields allow openings to be used until floodwaters reach a certain height. Passive flood shield systems may require room under the opening to allow the flood shield to be stored when it is not in use and may require a backup power supply.
