## WILLISTON BASIN DRAINAGE STUDY

**Williston Street at Evergreen Street  
Wheaton, DuPage County, Illinois**

City of Wheaton  
303 W. Wesley Street  
Wheaton, Illinois 60187

V3 Companies  
7325 Janes Avenue  
Woodridge, Illinois 60517  
630.724.9200

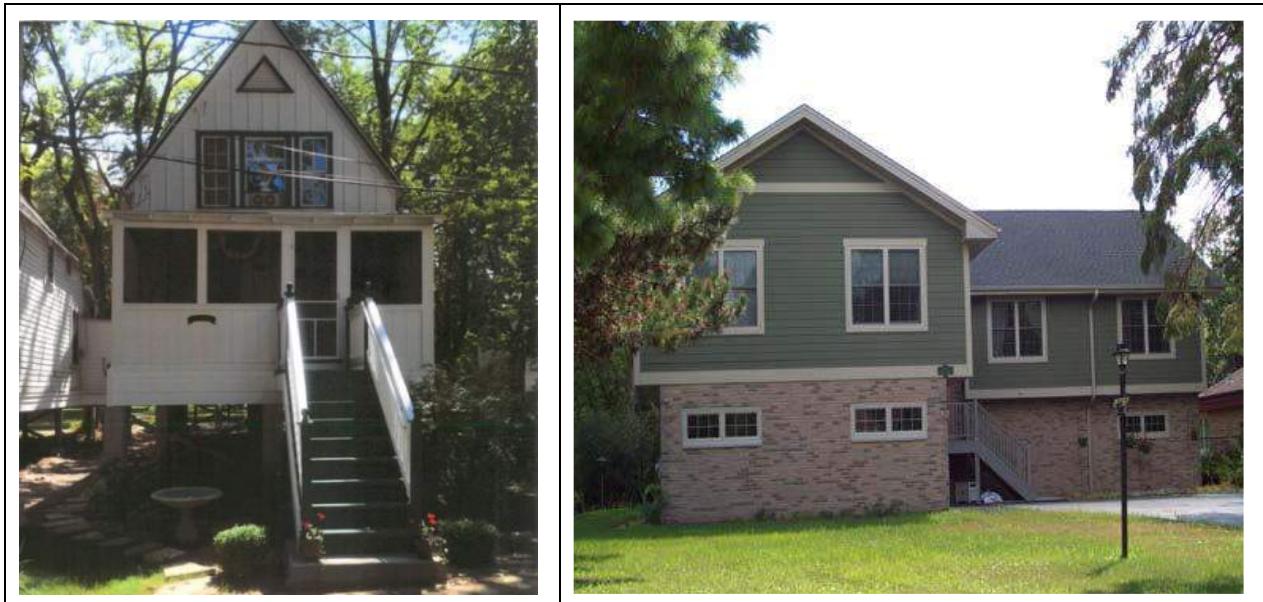
Elevation is usually most cost-effective for buildings on crawlspaces because it is easiest to get lifting equipment under the floor and disruption of the habitable part of the house is minimal. Examples of structures that have been elevated above the 100-year flood elevation are provided in Figure 11.

***Figure 11. Example Elevated Structures***
